July 13, 2005

**RE: Next Media Operating, Inc.
Work Plan Implementation Update
114 Tower Hill Road
Gilberts, Illinois**

CONFIRMATORY / DELINEATION
SAMPLE LOCATION MAP
114 TOWER HILL ROAD
GILBERTS, ILLINOIS

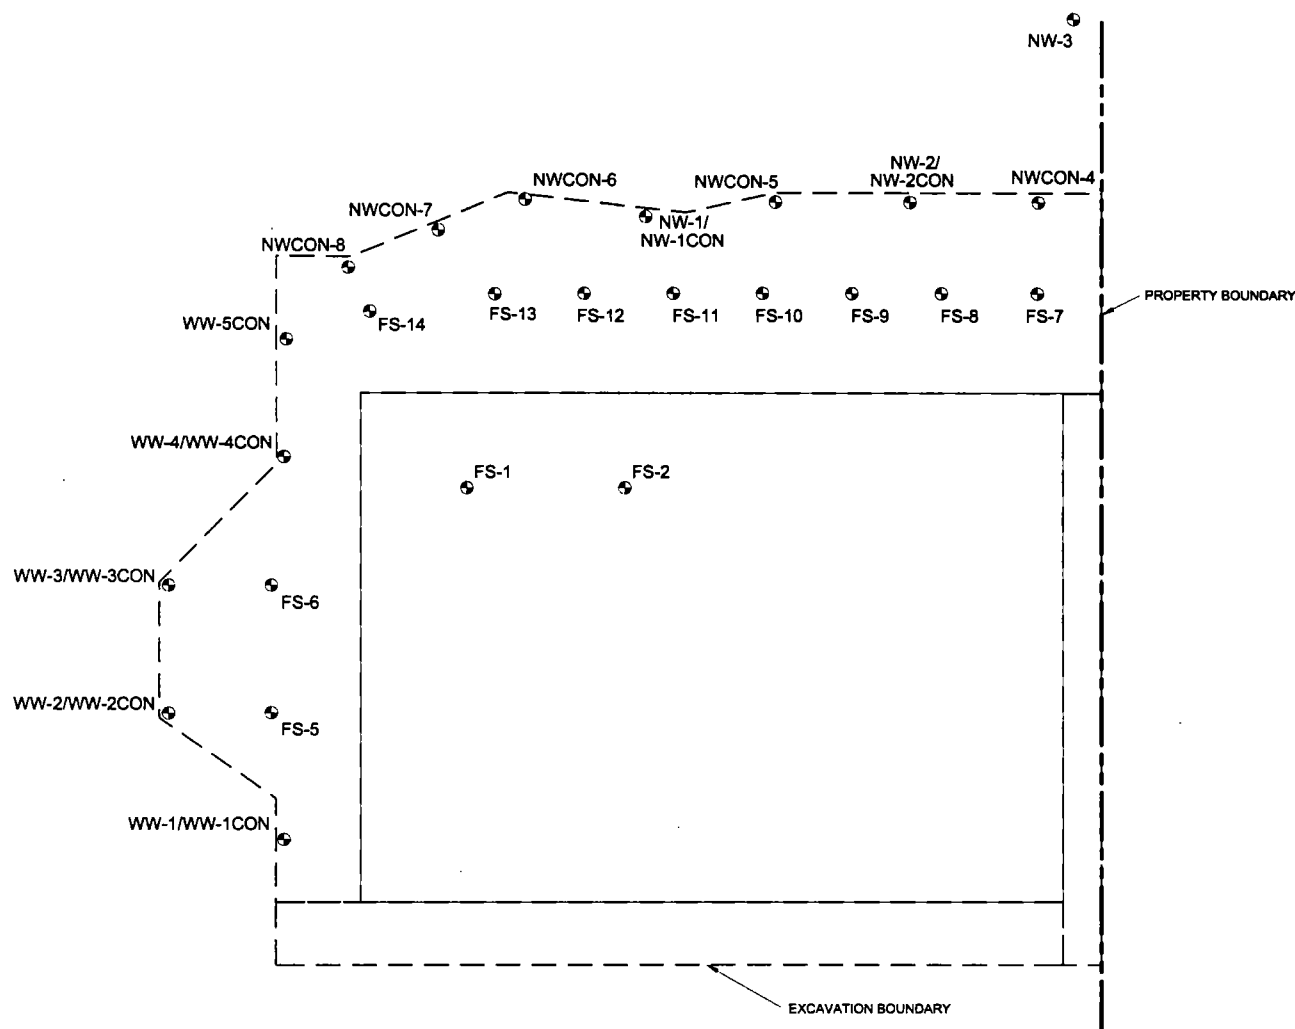
FIG. NO.: 1

Delineation along the west wall focused initially upon the surficial battery casings located beneath a row of trees, which were removed during the aforementioned Site Preparation activities (see Photos #26 and 27). The casings extended to a depth of approximately 2-3 feet bgs, and approximately 28 feet west of the existing excavation. URS screened four delineation samples (WW-1 through WW-4) and four corresponding confirmatory samples (WW-1CON through WW-4CON) with a portable X-Ray Fluorescence (XRF) analyzer. A total of eight soil samples were collected from trenching along the western portion of the excavation (see Photos #28-30). As stated in the USEPA-approved WP, these samples were collected from areas, which did not exhibit evidence of battery casings, and from soils that did not exceed an XRF screening value of 300 mg/kg. Please refer to the attached figure for the approximate sample locations.

The analytical results and XRF screening values obtained at the data points identified in the attached figure indicate that the total volume of lead-impacted soils located along the north and west excavation walls is approximately 685 cubic yards. This quantity is based upon a worst-case scenario in which the vertical extent of soils to be treated along the north and west excavation walls is four feet bgs. However, at least a portion of the soils located along the west wall extend down to an approximate depth of 2-3 feet bgs as these soils approach the adjacent wetland area. Based on the additional sample results, URS estimates that the total volume of soil to be treated and disposed of within the vicinity of the existing excavation to be approximately 1,000 cubic yards.

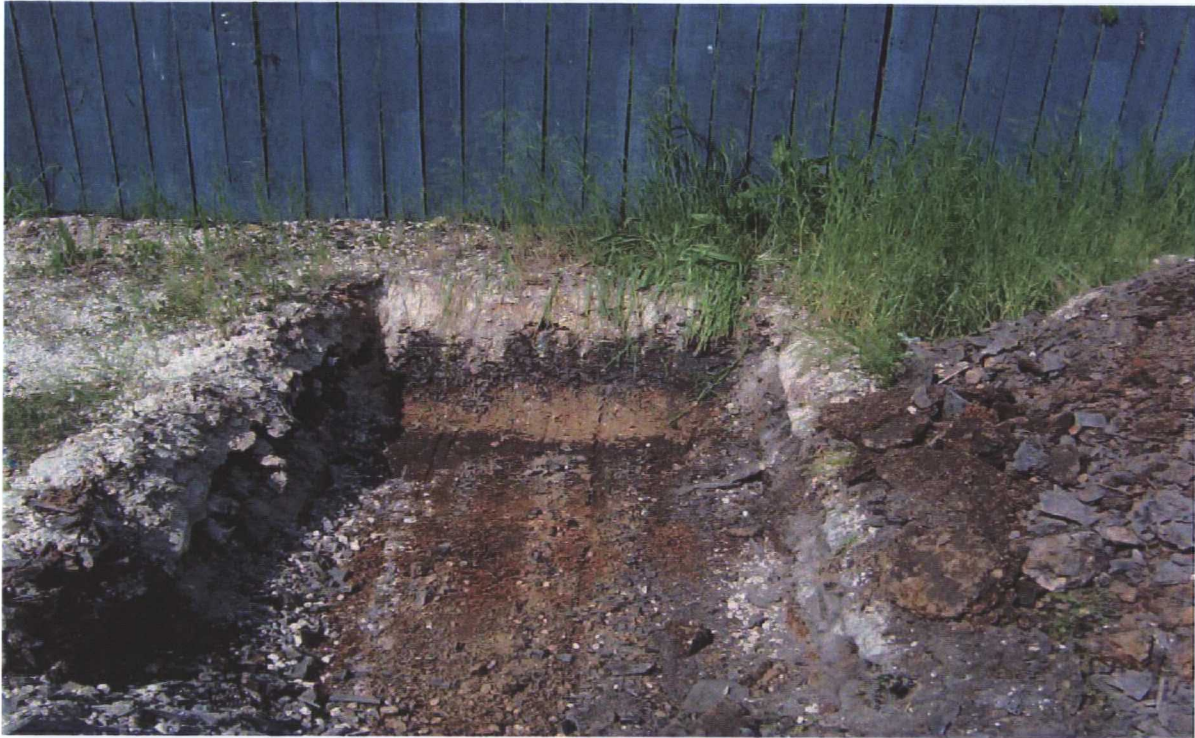
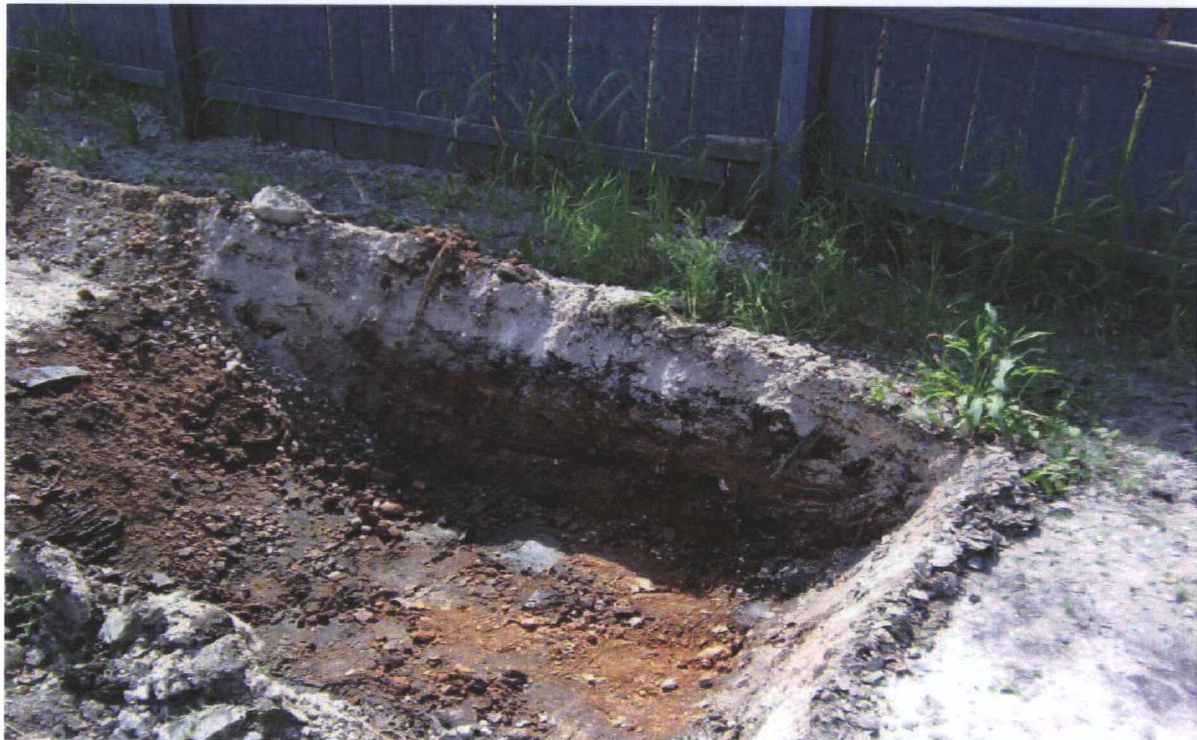
Photo 7/8 – USEPA test pits located south of Public Works Garage along property boundary indicating subsurface lead impacts (facing west/south).

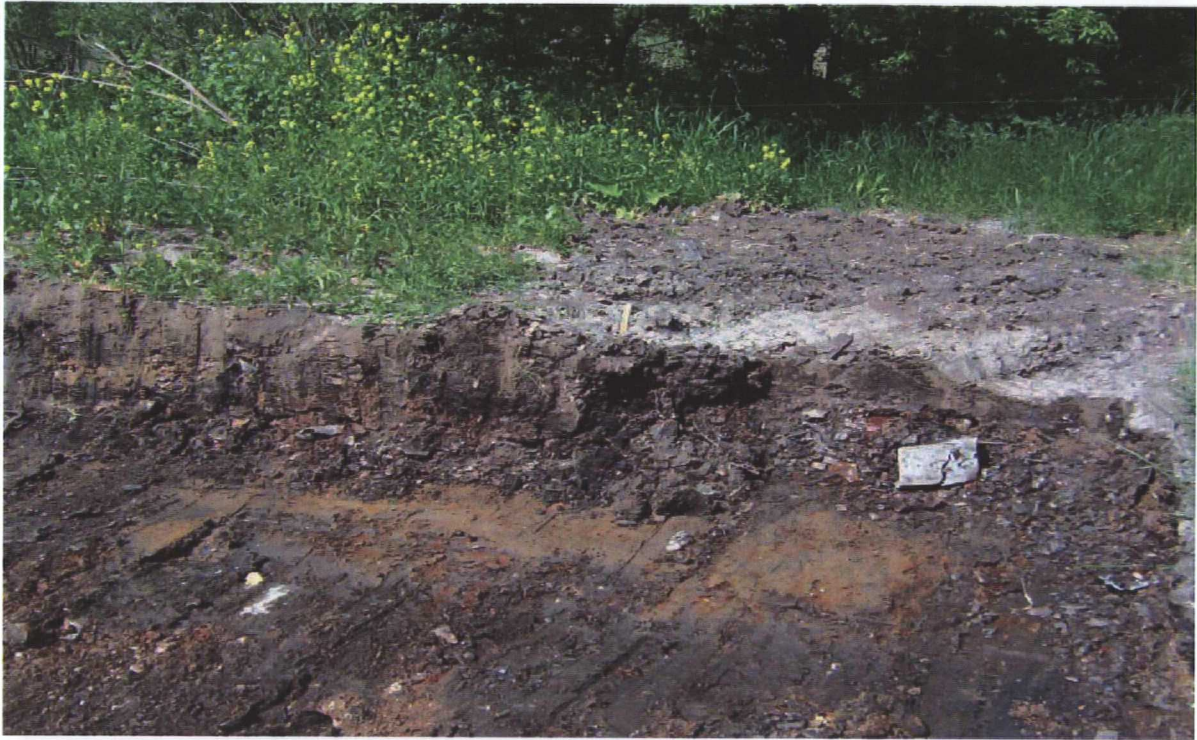
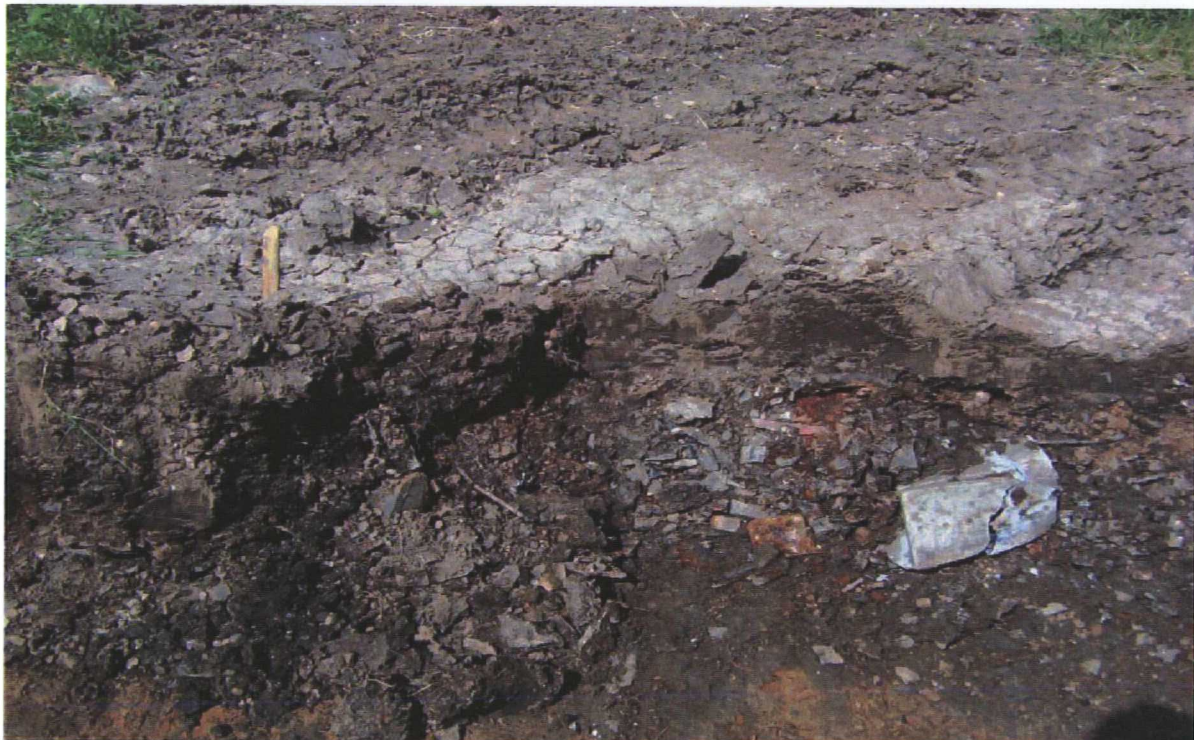
Photo 9/10 – USEPA excavation/remediation area along property boundary indicating presence of battery casings (facing west).

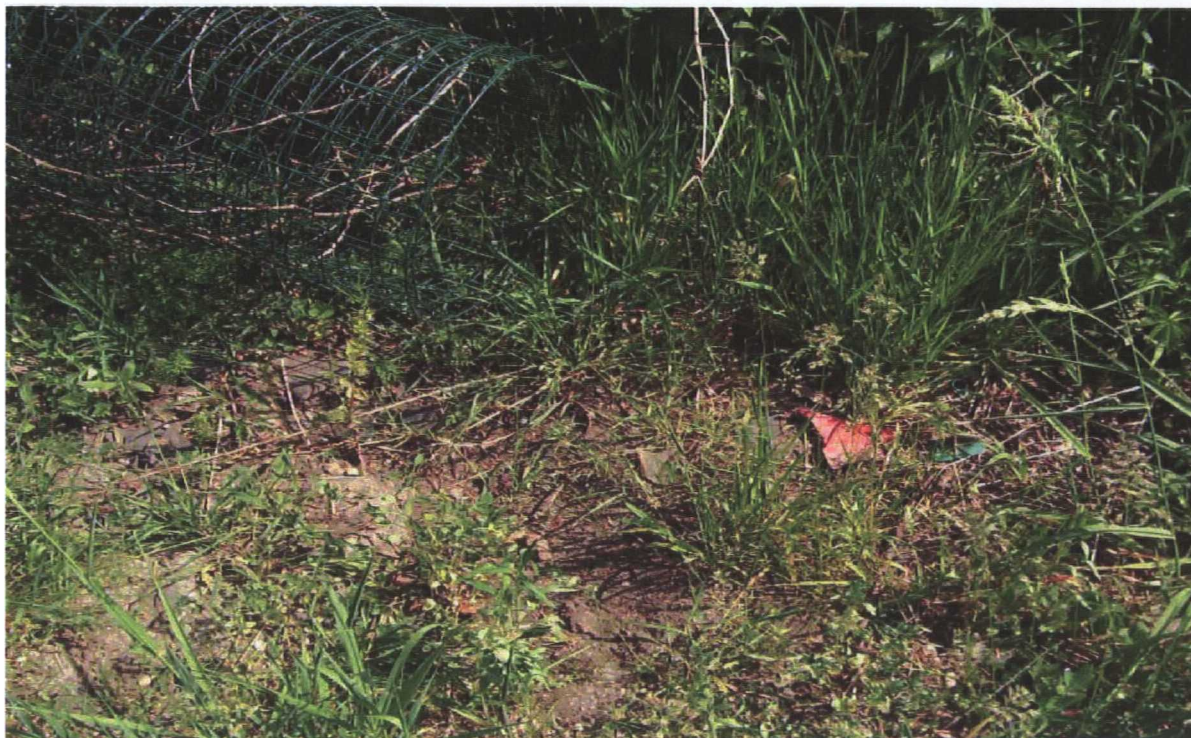
Photo 11 – Surficial battery casings located west of Public Works Garage on the Site (facing north).

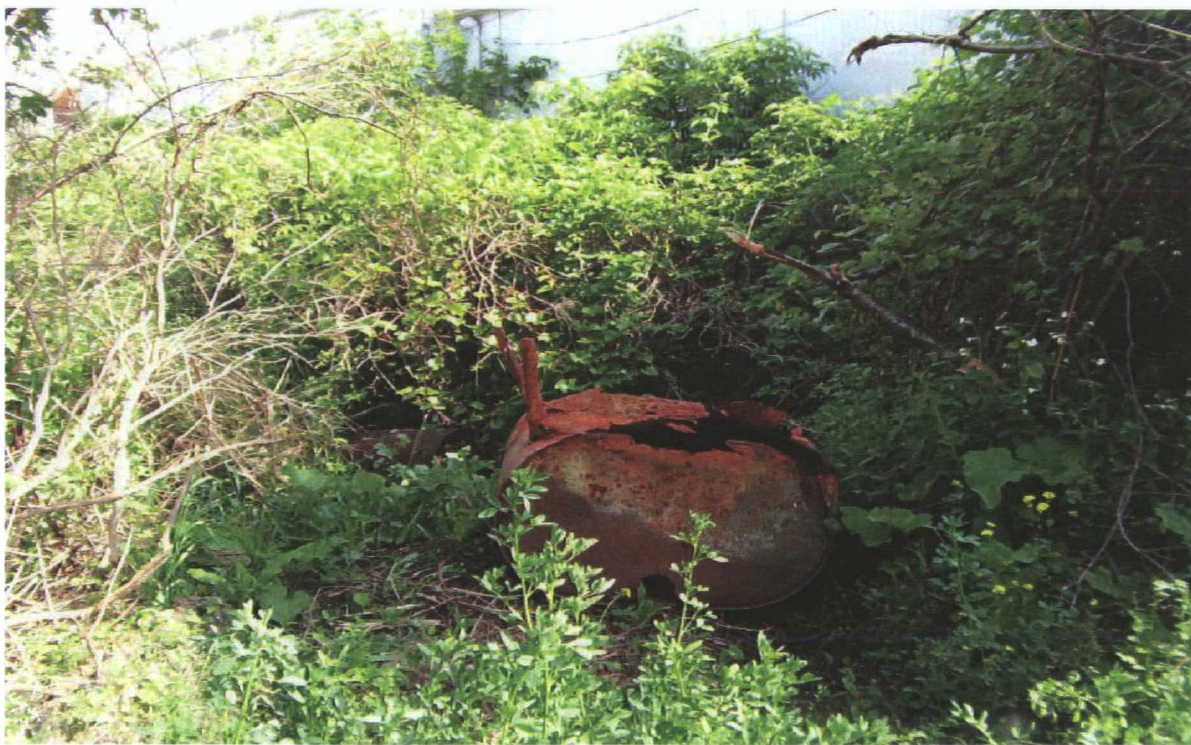
Photo 12 – Rusted aboveground storage tank located west of Public Works Garage on the Site (facing north).

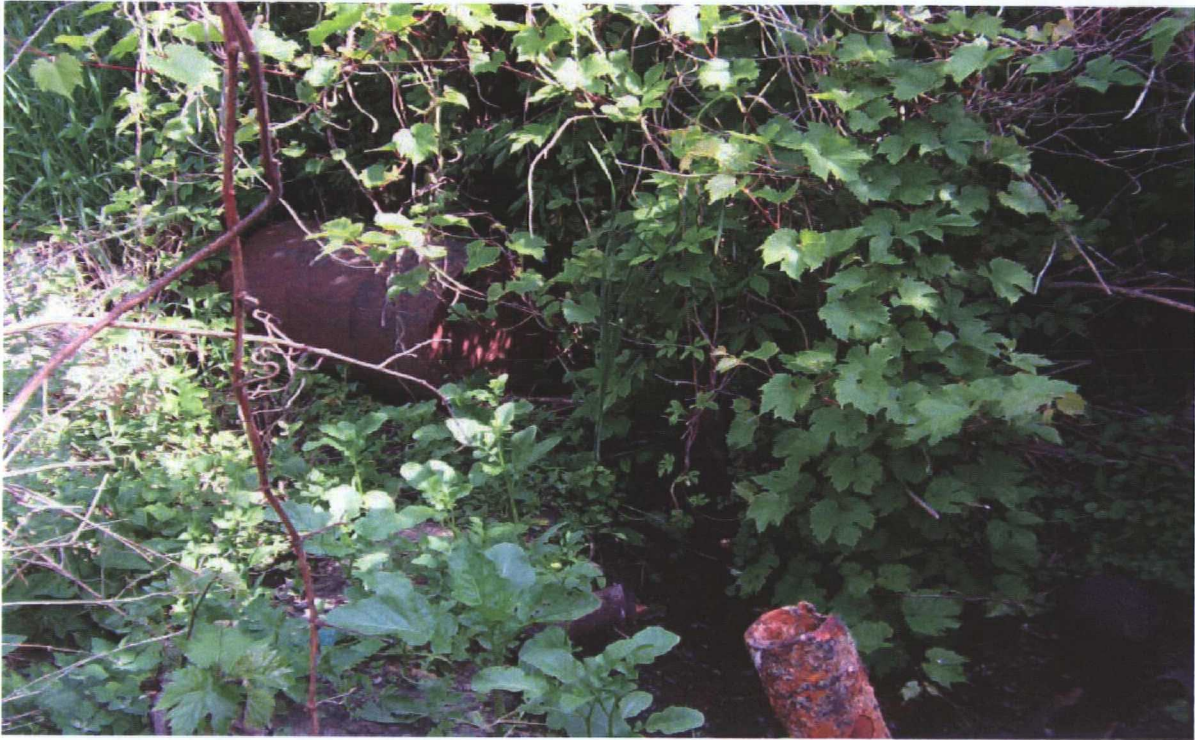
Photo 13 – Rusted drum located in wetland area west of Public Works Garage (facing north).

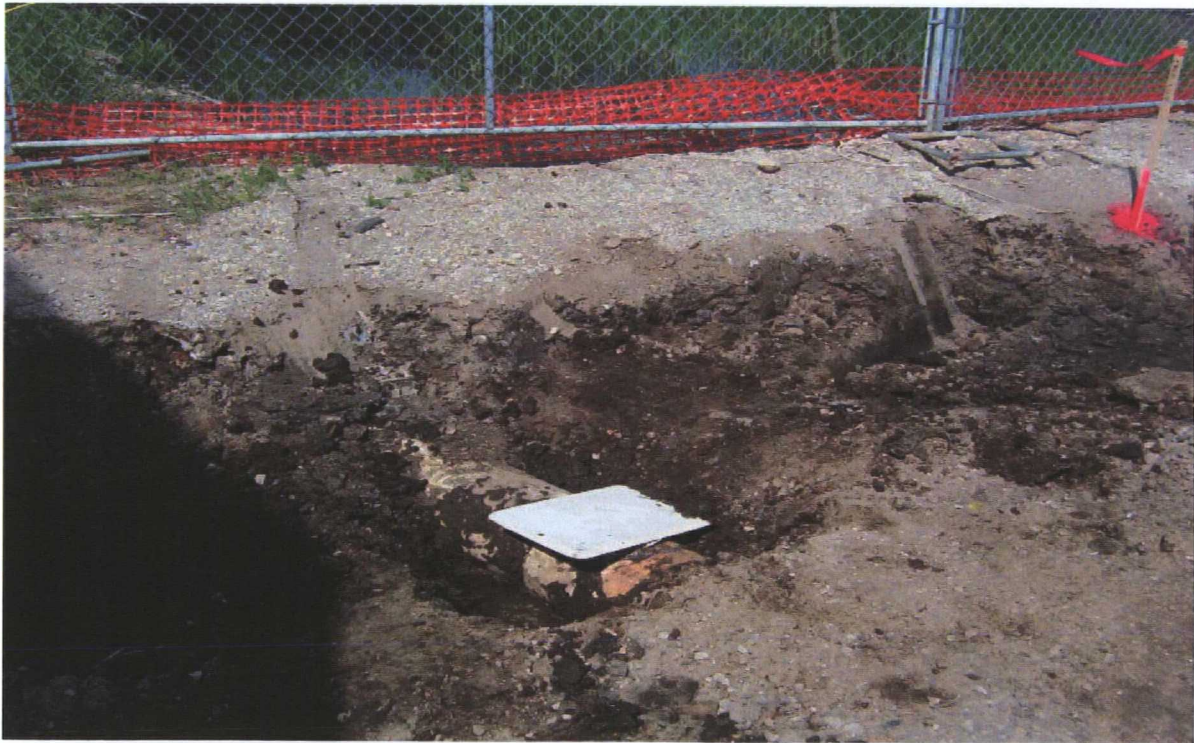
Photo 14 – View of damaged drainage piping on Village property along eastern boundary of the Site (facing west).

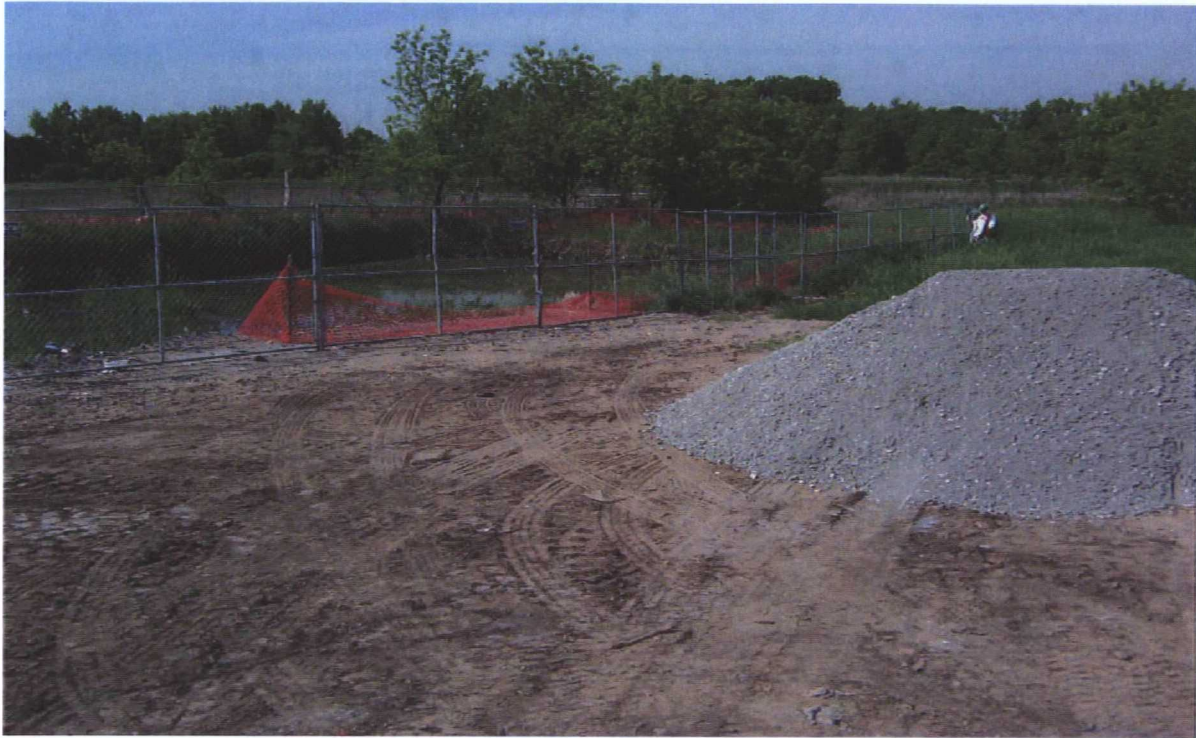
Photo 17 – View of Site during construction of temporary access road (facing west).

- Transfer of surficial battery casing fragments and immediately underlying soils to areas of the Site requiring treatment (see Photos #23, 26, and 27);
- Removal of trees, brush, and used tires (see Photos #19, 22, 24, and 25);
- Installation of a temporary gravel access road (see Photos #17 and 22) from the adjacent Village of Gilberts (Village) property;
- Surveying of the eastern property boundary; and
- Expansion of temporary construction fencing to encompass the entire remediation area (see Photo #22).

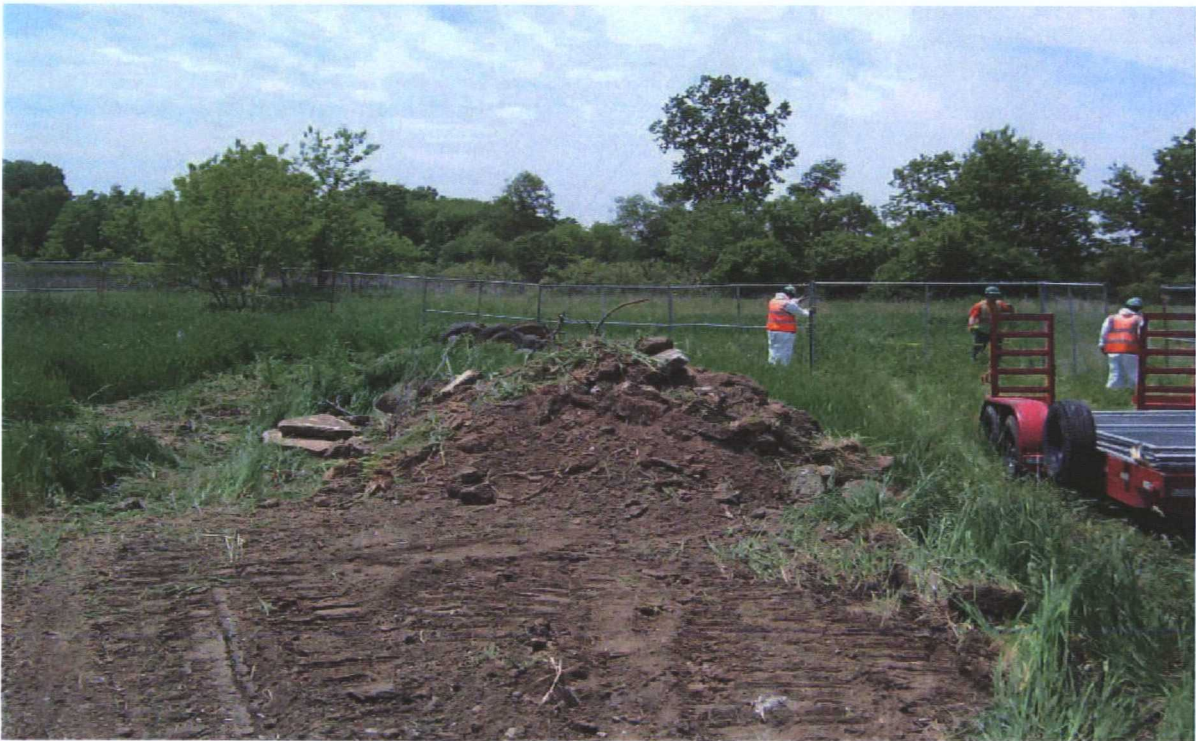
Photo 18 – Concrete debris unearthed during construction of temporary access road (facing west).

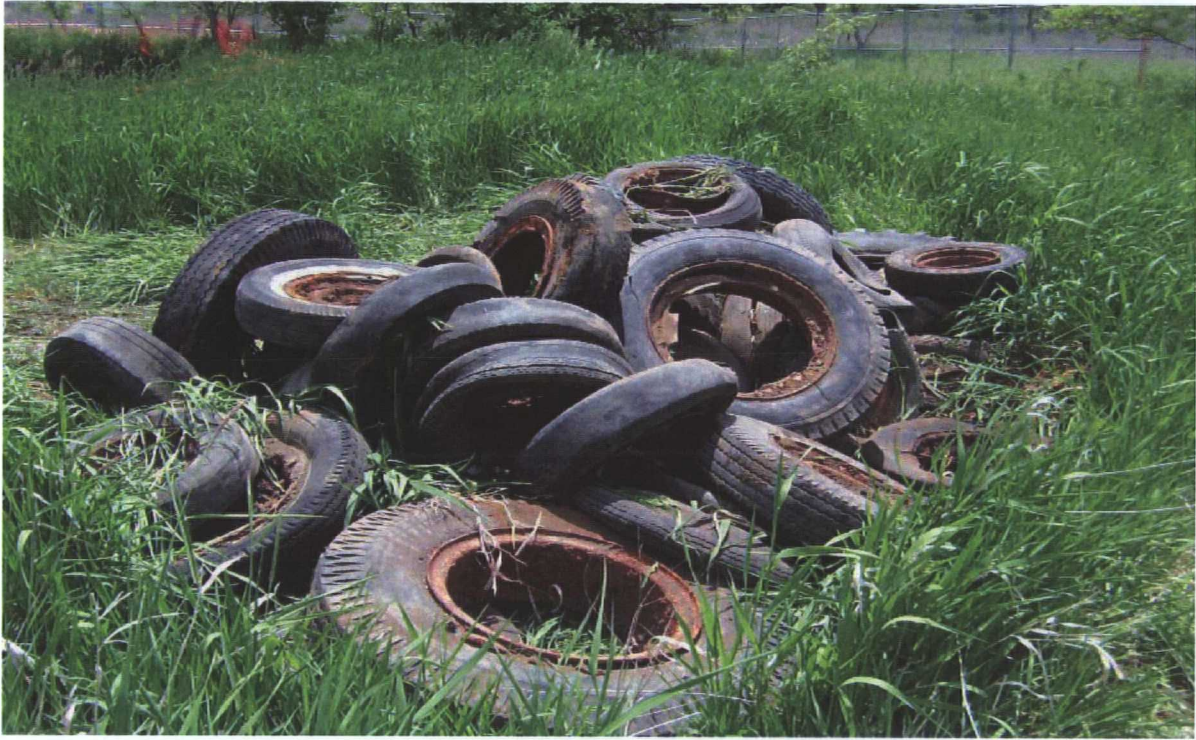
Photo 19 – Tires previously accumulated on Site during remediation activities (facing south).

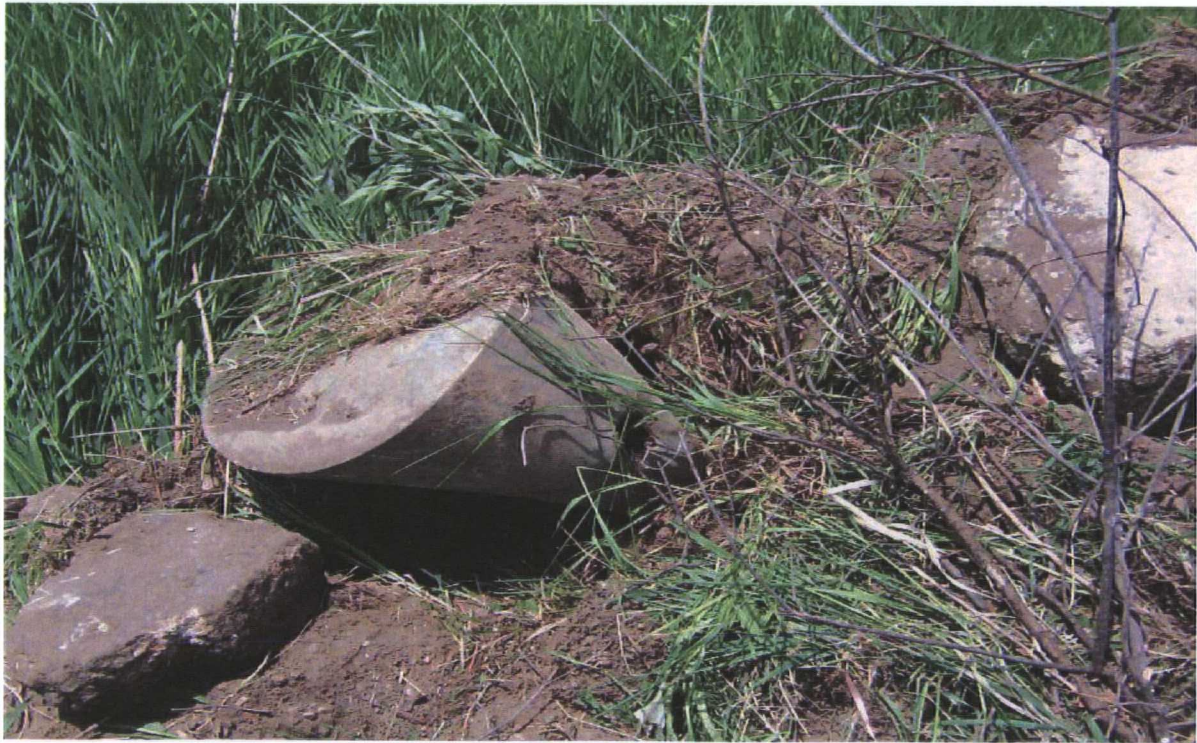
Photo 20 – Saddle tank unearthed during construction of temporary access road (facing north).

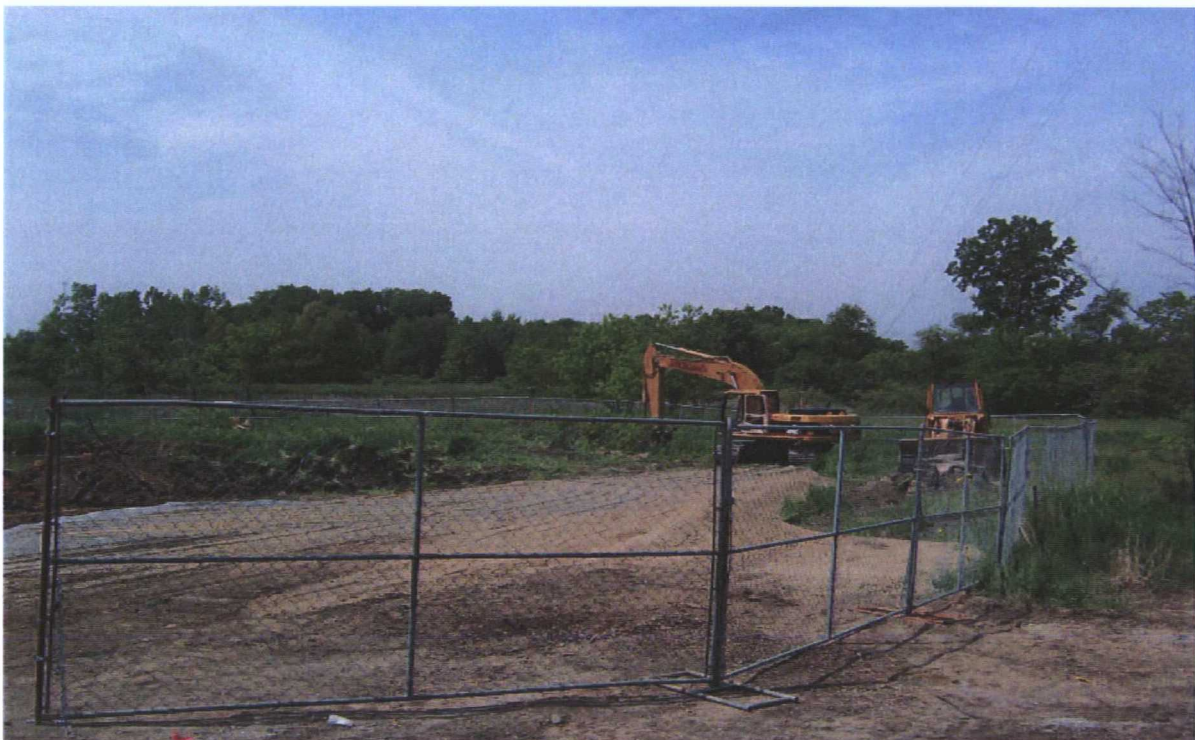
Photo 22 – Relocated fencing and construction of access road, tree and brush removal (facing west).

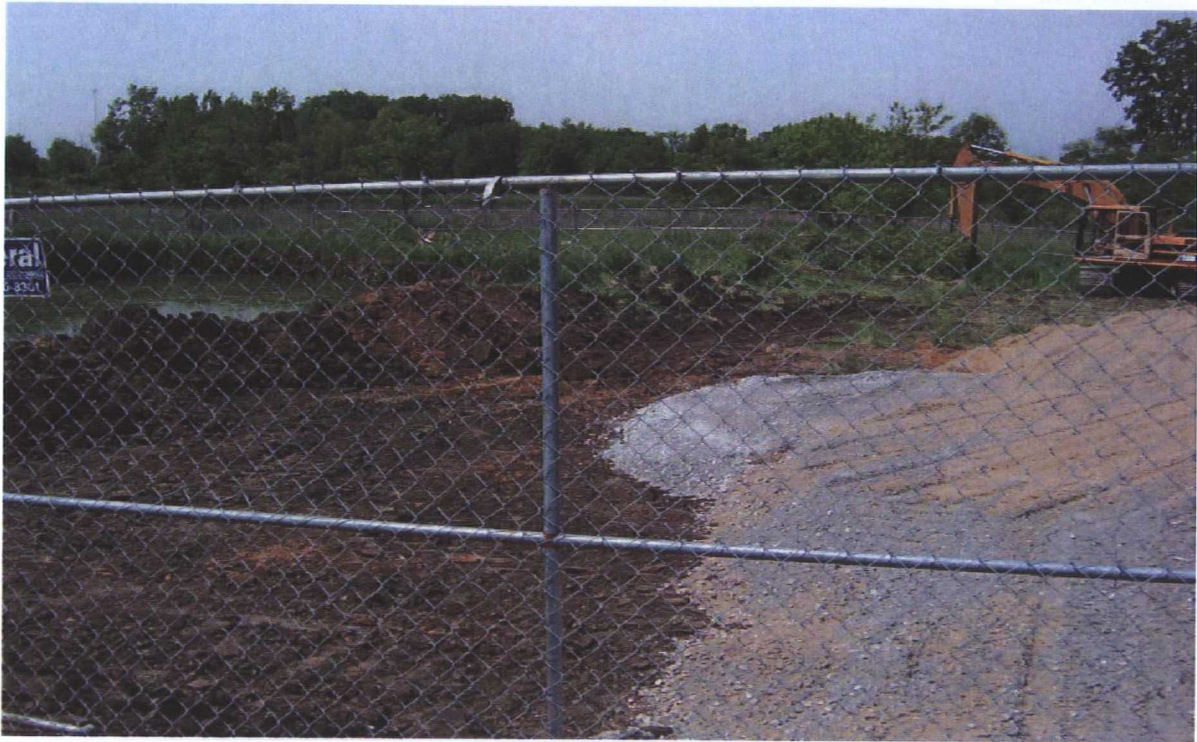
Photo 23 – Surficial casings and six inches of underlying soil relocated along north wall of excavation (facing west).

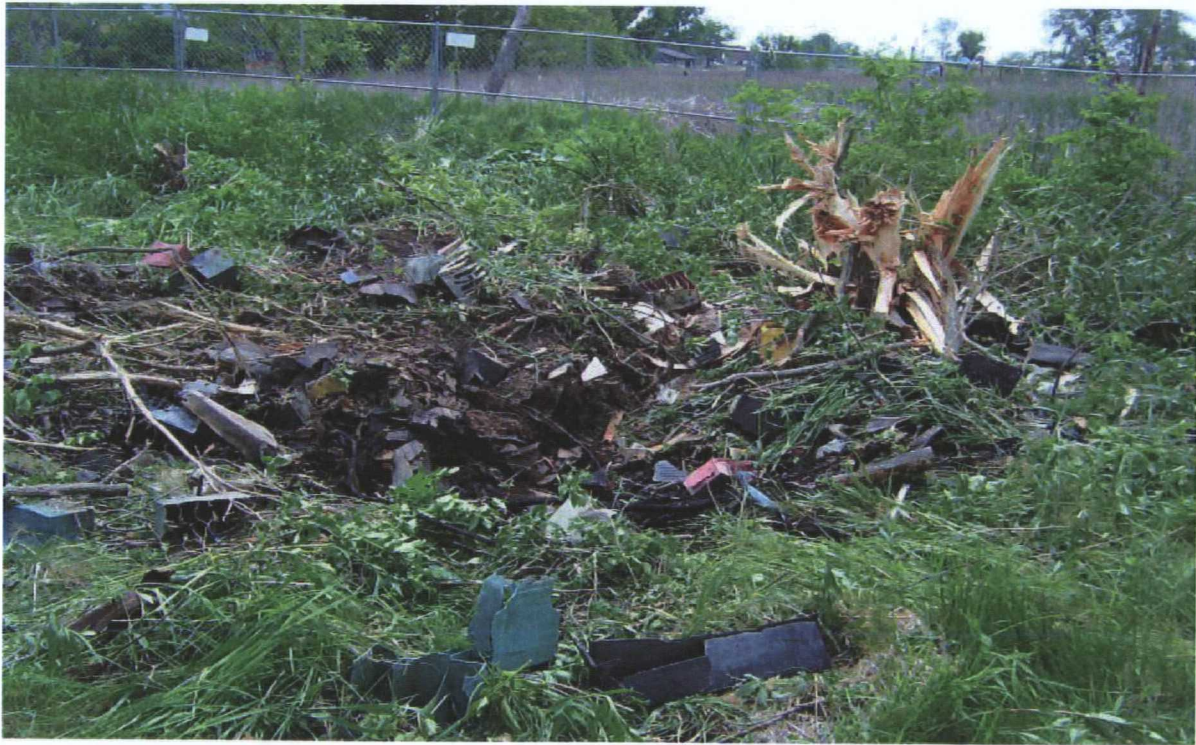
Photo 26 – Surficial battery casings within grubbed area along western boundary of existing excavation (facing south).

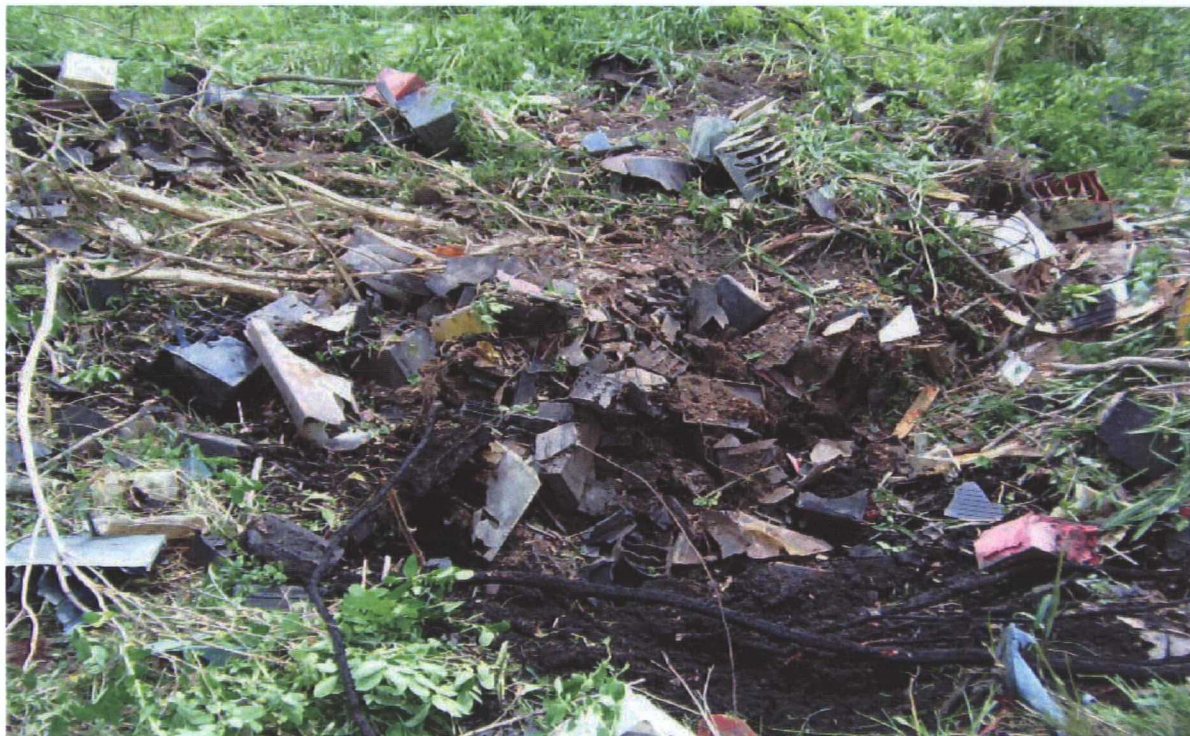
Photo 27 – Surficial and subsurface battery casings located along western excavation boundary (facing south).

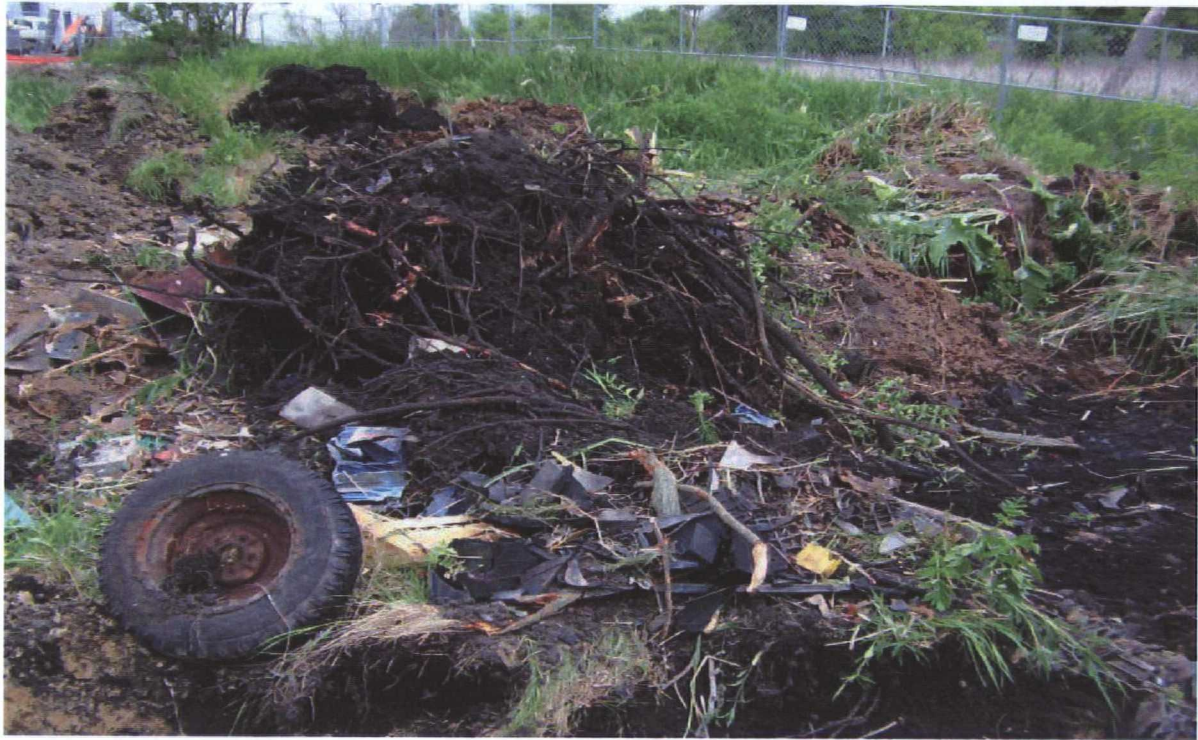
Photo 29 – Battery casings and debris unearthed during test trenching along western excavation boundary (facing south).

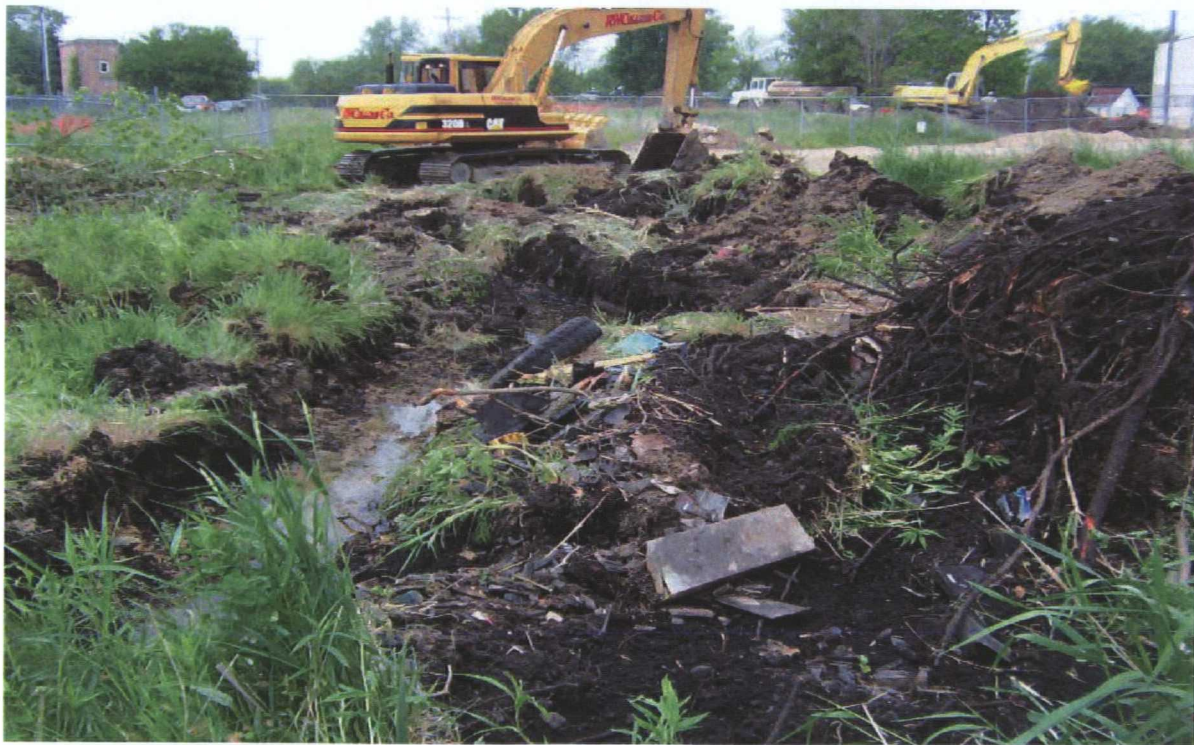
Photo 30 – Partial view of approximate extent of lead impacts along western excavation boundary (facing northeast).

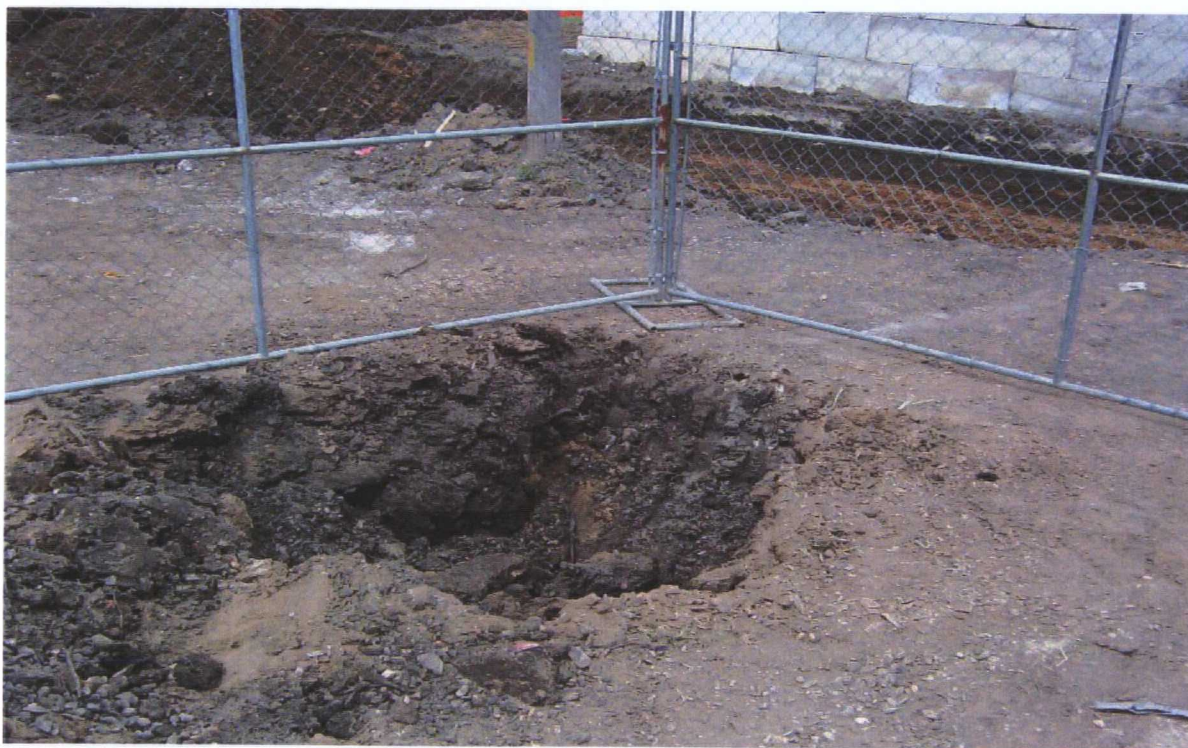
Delineation along the north excavation wall focused initially upon collecting two delineation samples (NW-1 and NW-2). URS collected a third delineation sample (NW-3) approximately 50 feet north of the northeast corner of the existing excavation (see Photos #34-36). URS consulted with USEPA to determine the location of NW-3, which was incorporated into the WP based upon analytical data obtained by USEPA on the Village property. URS collected a total of three delineation samples (NW-1 through NW-3) and three confirmatory samples (NW-1 CON, NW-2 CON, and NW CON-4) in delineating the north wall (see Photos #31-33). NW-1 CON and NW-2 CON corresponded to NW-1 and NW-2, whereas NW CON-4 was located approximately 24 feet north of the northeast corner of the existing excavation, where significantly higher lead levels were encountered during URS’ previous investigations. As explained above, these samples were screened with an XRF analyzer prior to submittal for laboratory analysis. URS completed its delineation sampling activities along the north and west excavation walls on June 3, 2005.

URS submitted a total of 14 soil samples to STAT Analysis Corporation (STAT) laboratory, a USEPA-approved contractor, for analysis of total lead. With the exception of sample NW-2, none of the samples exceeded the USEPA-approved remediation standard of 400 mg/kg. Sample NW-2 exhibited a total lead level of 940 mg/kg; however, the corresponding confirmatory wall sample (NW-2CON) exhibited a total lead level of 370 mg/kg. Based upon these results, URS concluded that the majority of lead-impacted soils has been delineated along the north and west walls of the existing excavation.

Photo 34 – View of delineation sample NW-3 (facing east).

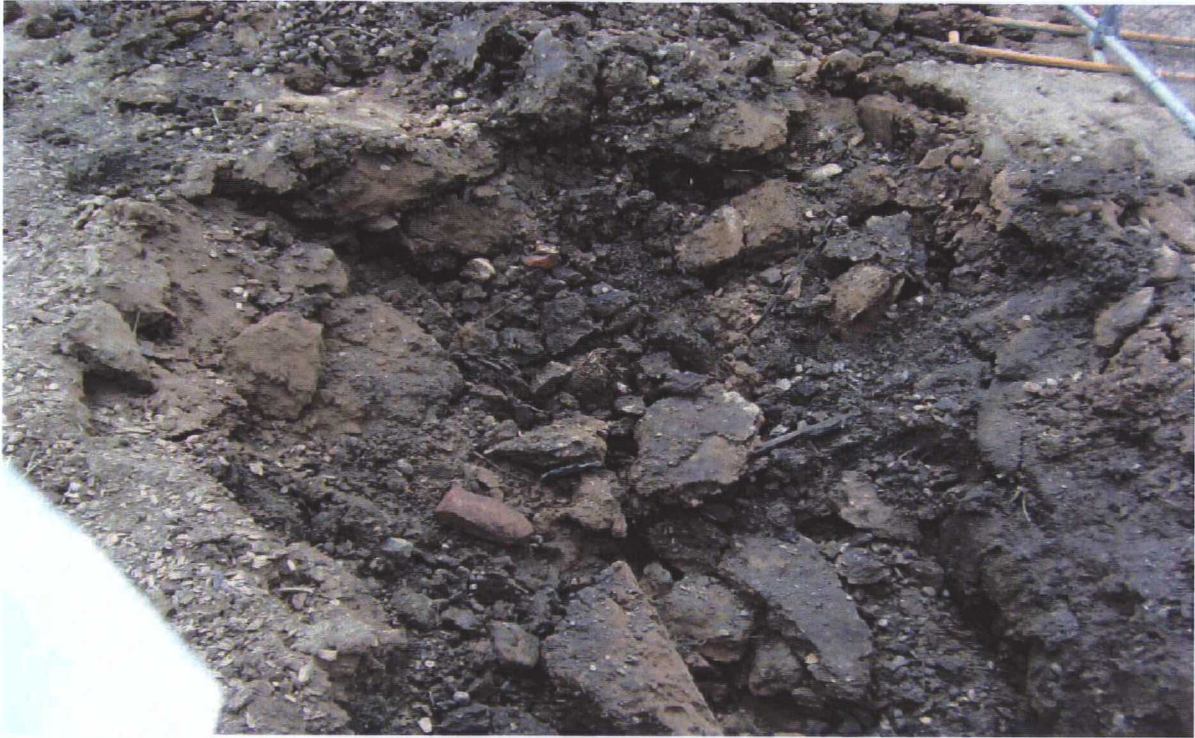
Photo 35 – View of delineation sample NW-3 (facing northwest).

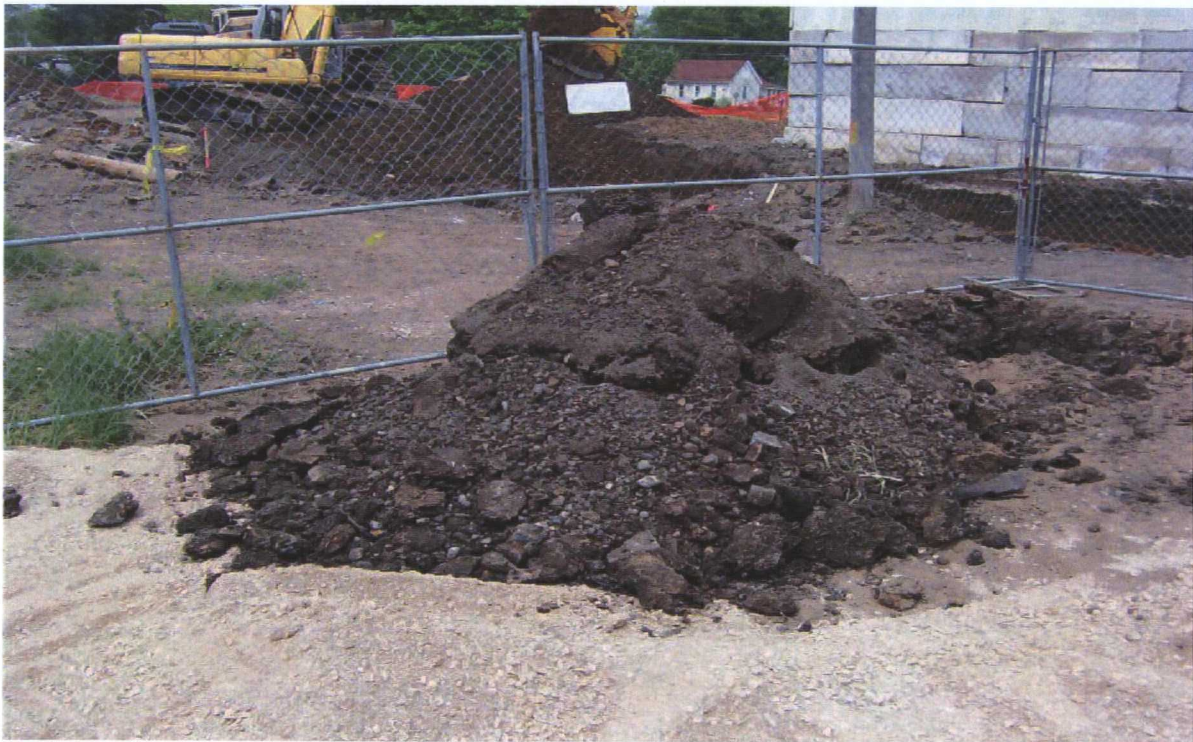
Photo 36 – View of soil removed from delineation sample NW-3 (facing northeast).
